DEPARTMENT OF TRANSPORTATION

Contract #: 04-0120F4Cty: SF/ALA Rte: 80 PM: 13.2/13.9File #: 69.28**WELDING INSPECTION REPORT****Resident Engineer:** Siegenthaler, Peter**Address:** 333 Burma Road**City:** Oakland, CA 94607**Report No:** WIR-021220**Date Inspected:** 30-Jan-2011**Project Name:** SAS Superstructure**OSM Arrival Time:** 700**Prime Contractor:** American Bridge/Fluor Enterprises, a JV**OSM Departure Time:** 1900**Contractor:** Zhenhua Port Machinery Company, Ltd (ZPMC), Changxing Island **Location:** Shanghai, China**CWI Name:** Geng Wei**CWI Present:** Yes No**Inspected CWI report:** Yes No N/A**Rod Oven in Use:** Yes No N/A**Electrode to specification:** Yes No N/A**Weld Procedures Followed:** Yes No N/A**Qualified Welders:** Yes No N/A**Verified Joint Fit-up:** Yes No N/A**Approved Drawings:** Yes No N/A**Approved WPS:** Yes No N/A**Delayed / Cancelled:** Yes No N/A**Bridge No:** 34-0006**Component:** OBG Components**Summary of Items Observed:**

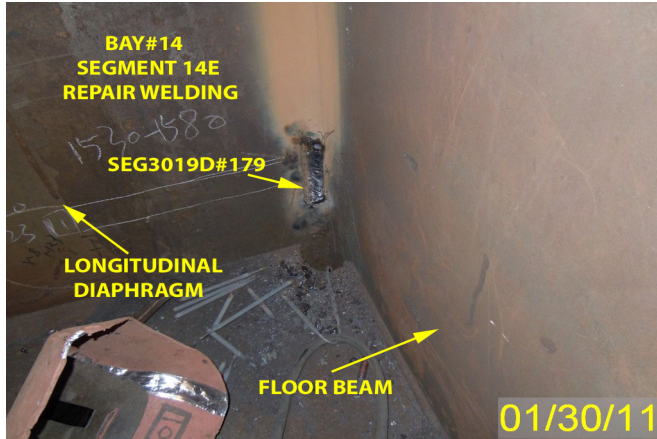
Repair welding of a weld joint #179 located on 14E, SEG3019D-1 as per the critical weld repair report #

B-CWR2745. Welder is identified as 044772. ZPMC Quality Control (QC) Inspector is identified as Guo Xing

Hui. The welding variables recorded by QC appeared to comply with the WPS-345-SMAW-3G

(3F)-FCM-Repair-1. (See attached photo)
